Hood River Middle School Music & Science Building Post Occupancy Evaluation

prepared for:

Energy Trust of Oregon

May 31, 2013

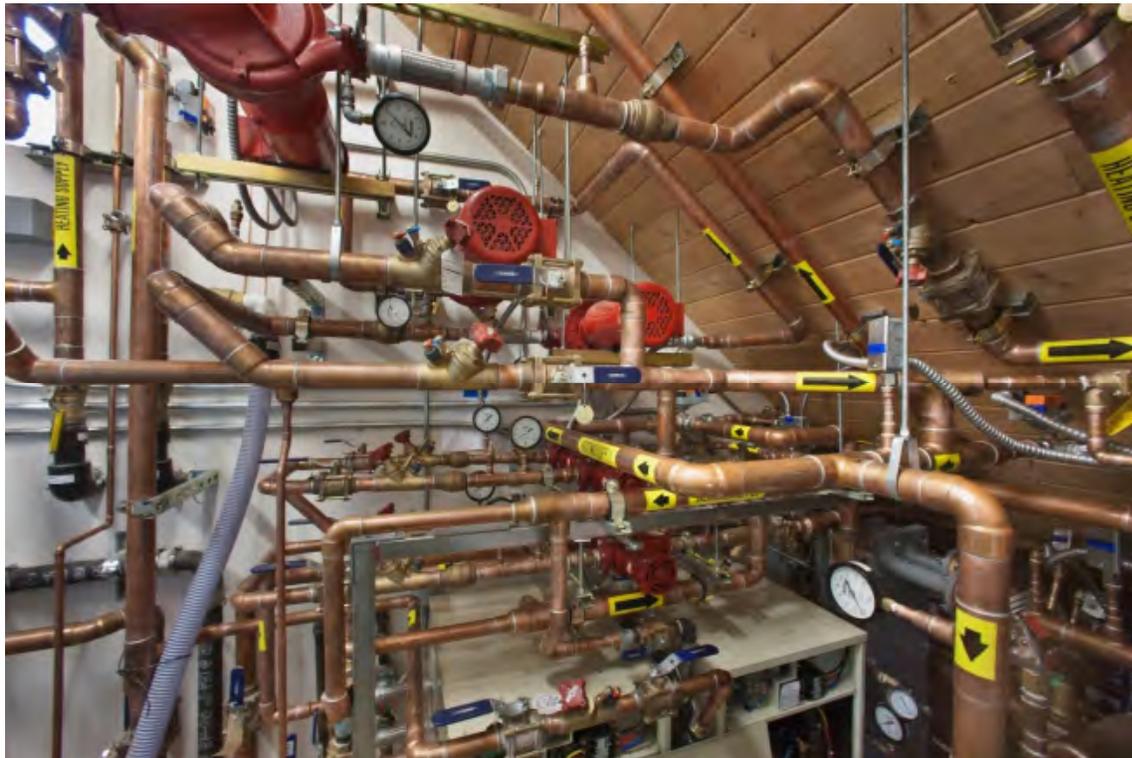
Mechanical system pumps and pipes fill the mezzanine space and can be seen through a window from the science classroom below.

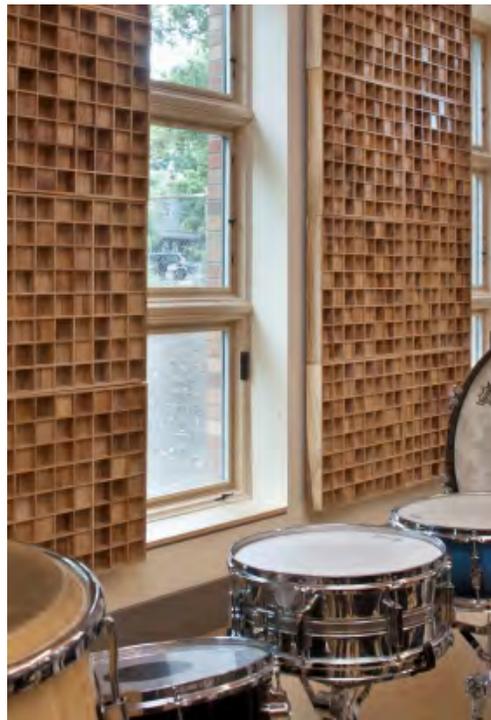
Diffuser panels in the music classroom.

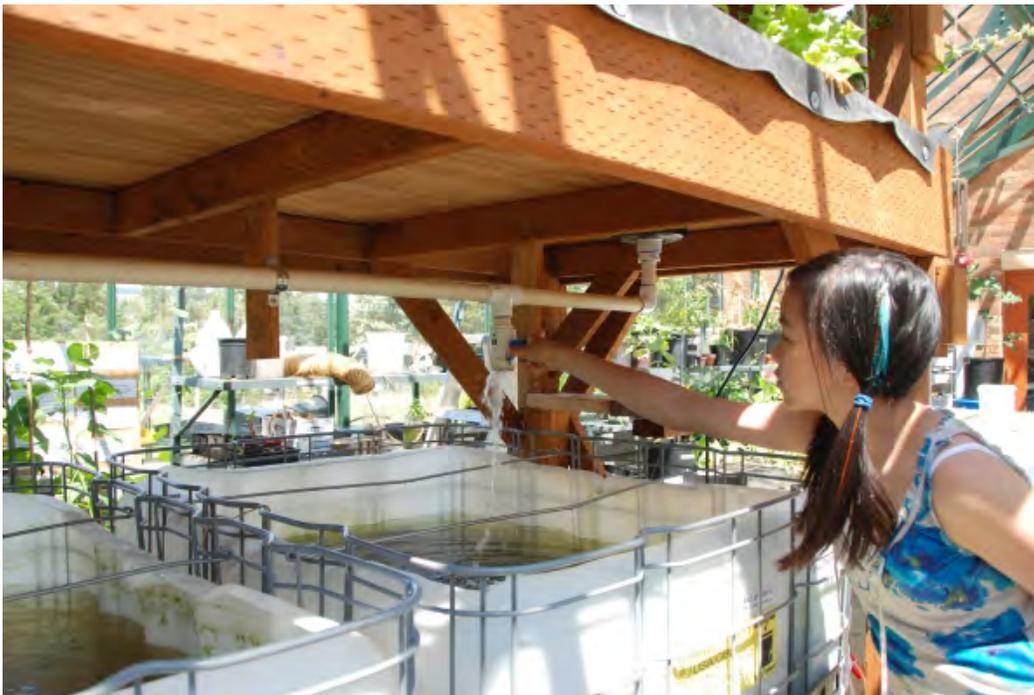
A biofiltration system that uses fish waste to fertilize plants in the greenhouse is an example of a student designed project.

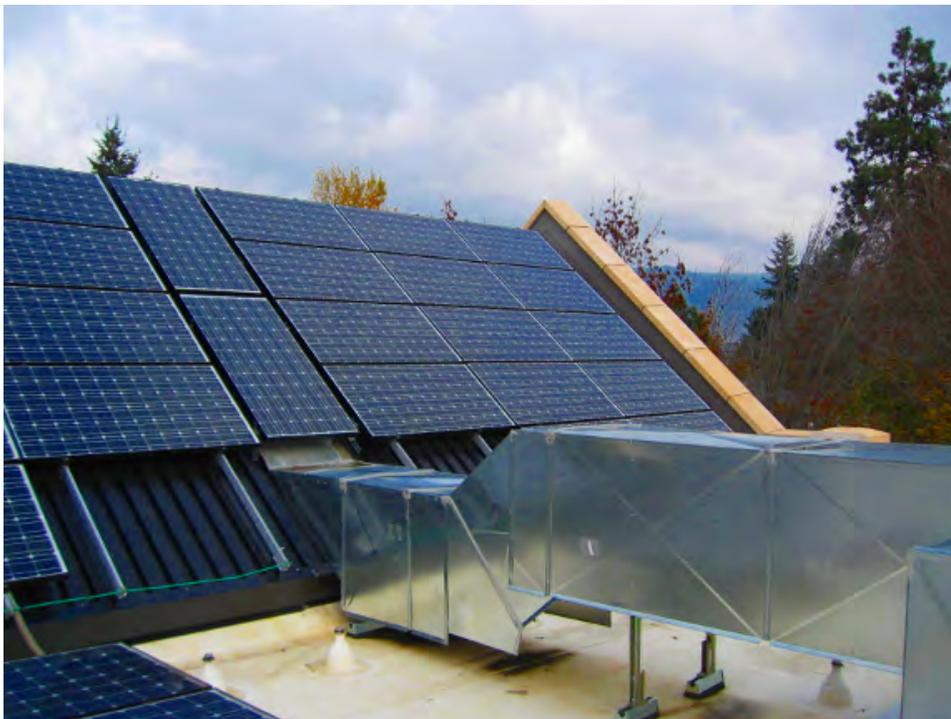
The ventilation for the building is provided via two rooftop heat recovery ventilators which serve displacement ventilation grilles in the classrooms. During appropriate outdoor conditions, operable windows can be used in the classrooms to provide natural ventilation with relief being provided via a roof mounted hood. In heating mode, the HRVs operate in a minimum ventilation mode only modulating up if space CO₂ levels climb above 1000ppm. Initially it was a concern that the ventilation system wasn't working appropriately because the HRVs were off during the post-occupancy walkthrough of the building. However the janitor said that the unit had just recently tripped off and hadn't been reset yet. During all subsequent log-ins to the DDC system it appeared that the HRVs were operating correctly and modulating based on space CO₂ concentrations. The HRVs are also connected to a 500 sf SolarWall array which acts to preheat the incoming ventilation air during the colder months. In warmer months there is a damper which bypasses the array. SolarWall is merely an angled plenum on the roof with a black perforated panel facing south. This panel serves to heat up the plenum and thus preheat the incoming air. At Hood River MS, PV panels are also installed on the SolarWall plenum due to space constraints. Unfortunately there weren't separate temperature sensors or submeters installed on the SolarWall array so we are unsure of its actual benefit. Infiltration was modeled at an average of 0.05 CFM/sf in the original energy model. There was no whole building pressurization test performed for the post-occupancy evaluation so the base infiltration rate remained unchanged in the calibrated model. While we are not able to verify infiltration rates, the monolithic nature of the insulated concrete formwork and careful attention that was paid to window detailing may outperform the estimates used in the model.
